Manhole Inspection Summary

Manhole # S23GG_050MH

Location Address: **1508 PRESSTMAN ST**

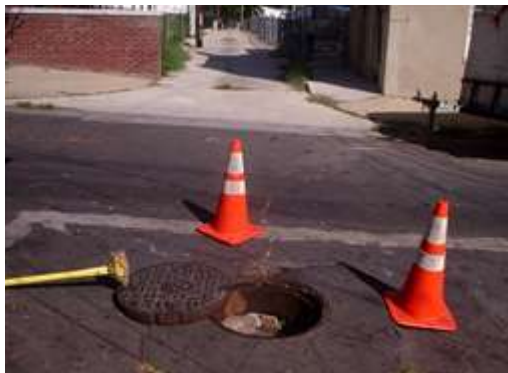
Location View

Pavement crack on pavement can cause infiltration

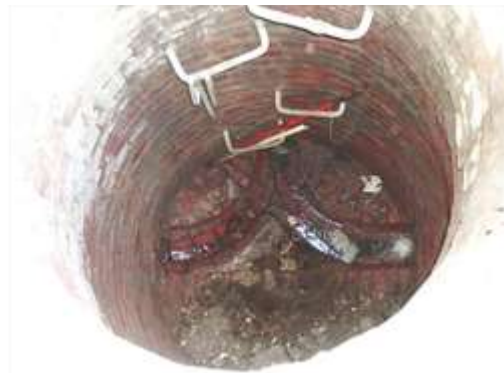
Top View

Evidence of surcharge - Bench debris. Channel debris.

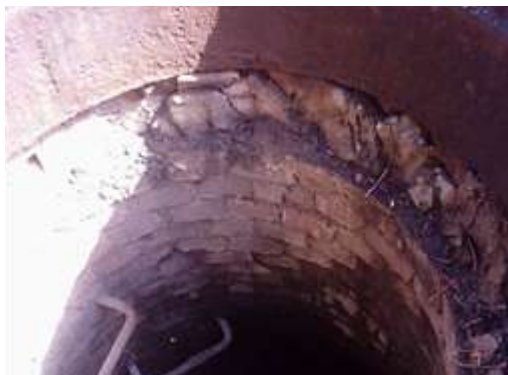
Defect

Frame leaks. Frame offset. Adjustment deterioration, loose brick and infiltration. Corbel infiltration.

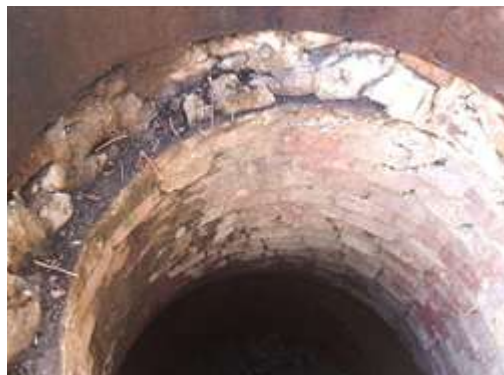
Defect

Frame leaks. Frame offset. Adjustment deterioration loose brick and infiltration. Corbel and Barrel infiltration.

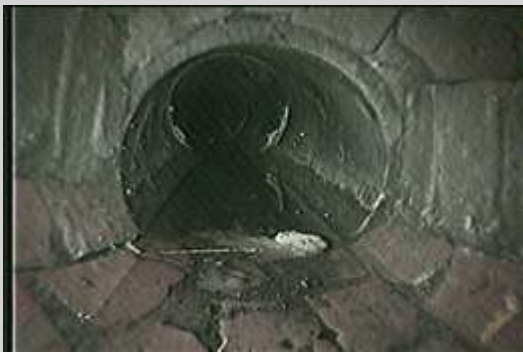
8 in. Circular Gravity Sewer Pipe Out @ 12 O'Clock

Infiltration: **Evidence** Pipe Seal Cond: **Cracked**

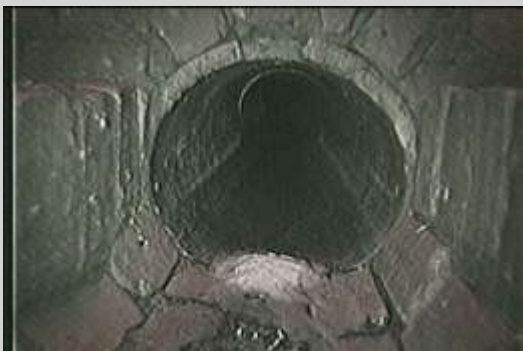
8 in. Circular Gravity Sewer Pipe In @ 3 O'Clock

Infiltration: **Evidence** Pipe Seal Cond: **Cracked**

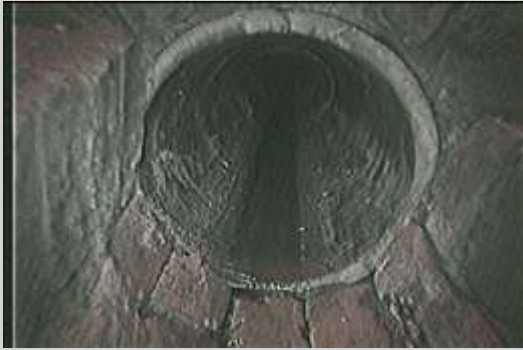
Pipe In @ 9 O'Clock

Infiltration: **Evidence**

Pipe Seal Cond: **Cracked**
